Manhole Inspection Summary

Manhole # S27E__029MH

Insp Date: **8/21/07 9:10 AM**

Location Address: **1001 SCHROEDER ST**

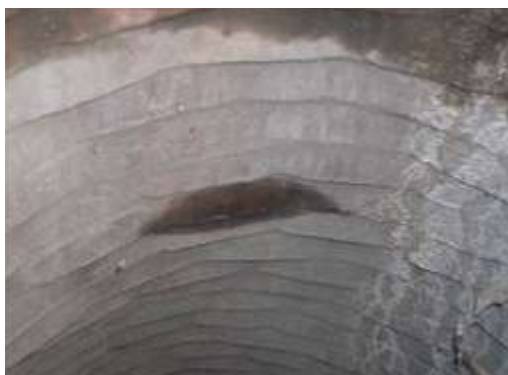
Defect 4

Infiltration: ☐ None ☐ Joint ☐ Cracks ☐ Mortar ☐ Roots ☒ **Wall**

INFILTRATION OF THE CORBEL WALL

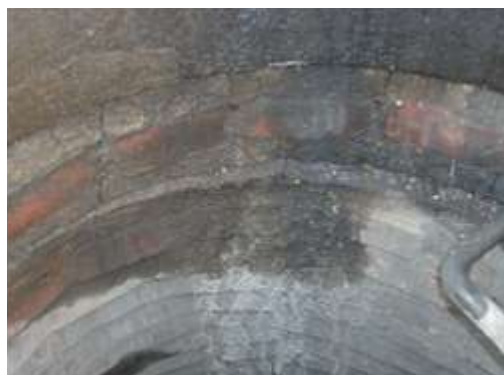
Defect 3

Infiltration: ☐ None ☒ **Joint** ☐ Cracks ☐ Mortar ☐ Roots ☐ Wall

INFILTRATION OF THE JOINT

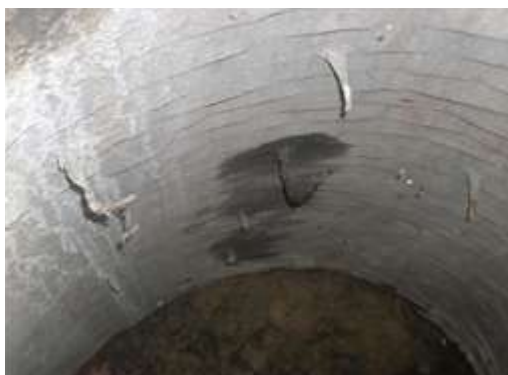
Defect 2

Infiltration: ☐ None ☐ Joint ☐ Cracks ☐ Mortar ☐ Roots ☒ **Wall**

Count: **1** Missing: **4** ☐ Corroded

MISSING STEPS AND INFILTRATION
OF THE BARREL WALL

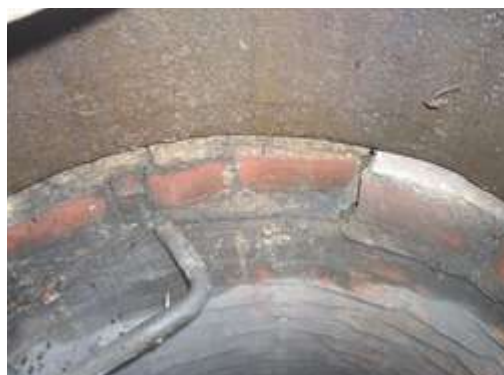
Defect 1

Condition: ☐ Sound ☒ **Cracked** ☐ Root Intrusion ☐ Loose Brick ☐ Deteriorated

CRACKED CHIMNEY

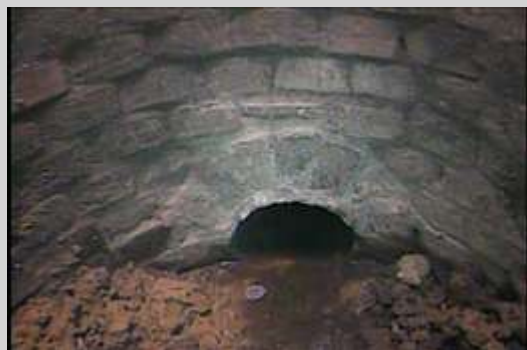
12 O'Clock Outflow

Deposits: ☐ None ☐ Mud ☐ Sludge ☒ **Debris** ☐ Grease

Silt Depth: **3** (in.) Deposits Extent: **Medium**
